School Assessment Report

District: Hi-Plains R-23
School: Hi-Plains ES
Date: Apr 01, 2011

School Name: Hi-Plains ES

The Hi-Plains Elementary School consists of one building located on 1475 2nd Avenue, in Vona, Colorado. The original campus was constructed in 1917. This report contains condition and adequacy data collected during the fiscal year 2009 "Statewide Financial Assistance Priority Assessment." The detailed condition and deficiency statements are contained in this report for each building.

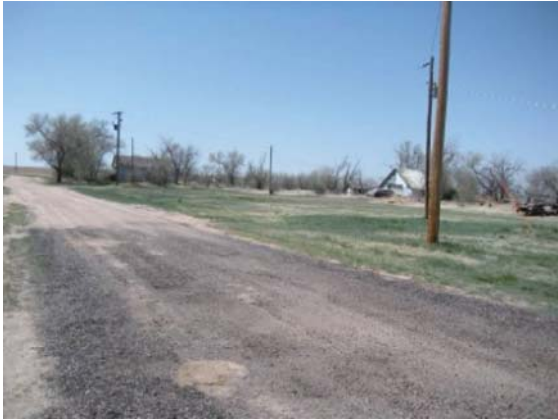
System: G2010 - Roadways

Analysis: The system age is either beyond expected life or does not meet its intended performance under the Guidelines. The system may be in service and functioning but it is recommended to be replaced due to probable increased condition budget needs, the potential failure of its components, or in order to meet the performance Guidelines for this system. The system was installed in 1917. It has a 50-year service life which expired in 1967.

Notes: Driveways are beyond expected life and need resurfacing. Also recommend installation of traffic signage per guidelines in Exhibit C.

Recommendation: The system should be replaced.

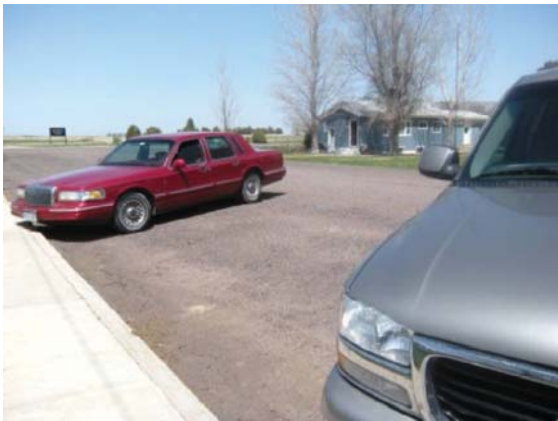
System: G2020 - Parking Lots

Analysis: The system age is either beyond expected life or does not meet its intended performance under the Guidelines. The system may be in service and functioning but it is recommended to be replaced due to probable increased condition budget needs, the potential failure of its components, or in order to meet the performance Guidelines for this system. The system was installed in 1917. It has a 50-year service life which expired in 1967.

Recommendation: The system should be replaced.

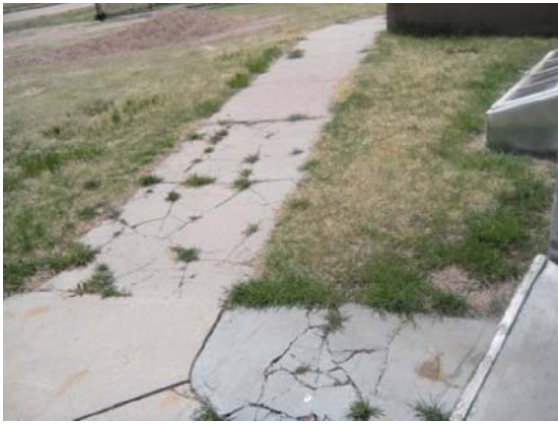
System: G2030 - Pedestrian Paving

Analysis: The system age is either beyond expected life or does not meet its intended performance under the Guidelines. The system may be in service and functioning but it is recommended to be replaced due to probable increased condition budget needs, the potential failure of its components, or in order to meet the performance Guidelines for this system. The system was installed in 1917. It has a 50-year service life which expired in 1967.

Location: Site
Distress: Beyond Expected Life
Category: Deferred Maintenance
Priority: 3 - Necessary- 2-5 Yrs
Notes: Pedestrian pavings are old and beyond expected life. Recommend replacement.

Recommendation: The system should be replaced.

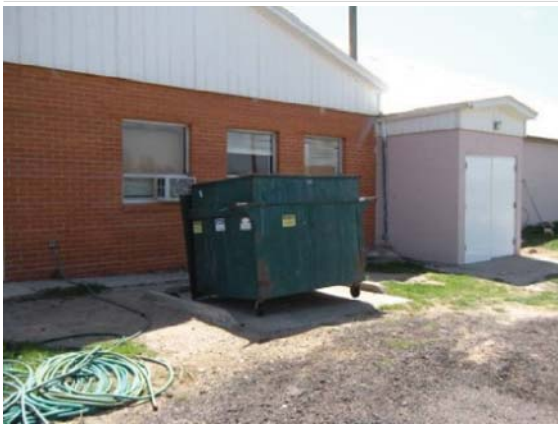
System: G2040 - Site Development

Analysis: The system is missing.

Location: Site
Material: Site Development
Distress: Missing
Category: Environmental
Priority: 3 - Necessary- 2-5 Yrs
Notes: Fencing around rubbish containers is missing. Installation is recommended.

Recommendation: The system should be installed.

Correction: Replace and/or add fencing for security/appearance

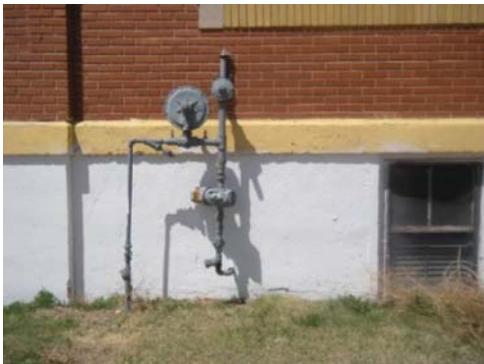
Location: Site
Material: Site Development
Distress: Missing
Category: Compliance
Priority: 3 - Necessary- 2-5 Yrs
Notes: Fencing around natural gas meter is missing. Installation is recommended.

Correction: Replace and/or add fencing for security/appearance

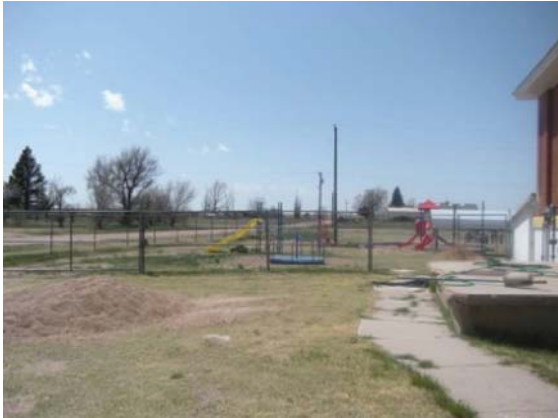
System: G2050 - Landscaping

Analysis: The system age is either beyond expected life or does not meet its intended performance under the Guidelines. The system may be in service and functioning but it is recommended to be replaced due to probable increased condition budget needs, the potential failure of its components, or in order to meet the performance Guidelines for this system. The system was installed in 1917. It has a 10-year service life which expired in 1927.

Location: Site
Distress: Beyond Expected Life
Category: Deferred Maintenance
Priority: 3 - Necessary- 2-5 Yrs
Notes: The landscaping is minimal and does not aid passive solar techniques. The grass has burnt patches and needs to be reworked.
Correction: Renew System
Qty: 1-Ea.
Condition Budget: \$101,013

Recommendation: The system should be replaced.

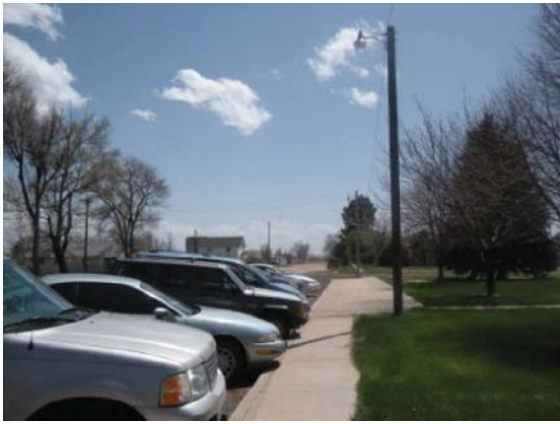
System: G4020 - Site Lighting

Analysis: The system age is either beyond expected life or does not meet its intended performance under the Guidelines. The system may be in service and functioning but it is recommended to be replaced due to probable increased condition budget needs, the potential failure of its components, or in order to meet the performance Guidelines for this system. The system was installed in 1917. It has a 30-year service life which expired in 1947.

Notes: Site lighting is beyond expected life. Recommend replacement.

Recommendation: The system should be replaced.

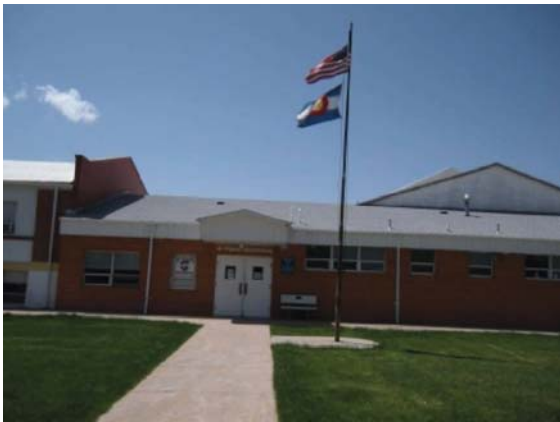
System: G4030 - Site Communication and Security

Analysis: The system is missing.

Notes: The school does not have security cameras. It has no bollards to protect the forced entry. Recommend installation of both systems.

Recommendation: The system should be installed.

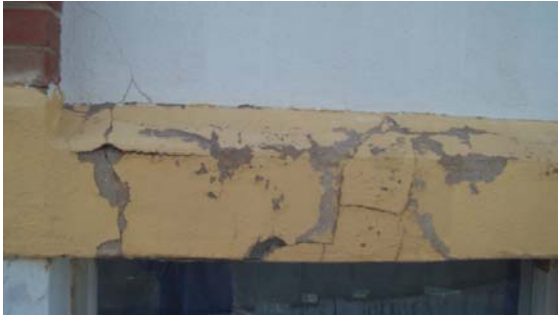
System: B2010 - Exterior Walls

Analysis: The system is in use and functioning with an estimated remaining service life as indicated in the report section "Condition/Replacement Budget Detail". The system was installed in 1917. It has a 100-year service life. However, in the assessment, it was found to be currently deficient and is non-renewable.

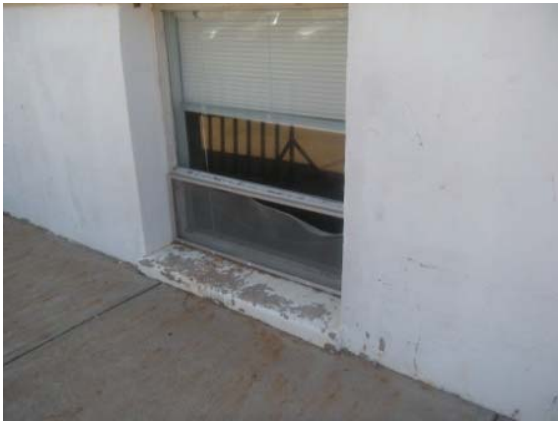
System: B2020 - Exterior Windows

Analysis: The system age is either beyond expected life or does not meet its intended performance under the Guidelines. The system may be in service and functioning but it is recommended to be replaced due to probable increased condition budget needs, the potential failure of its components, or in order to meet the performance Guidelines for this system. The system was installed in 1917. It has a 30-year service life which expired in 1947.

Recommendation: The system should be replaced.

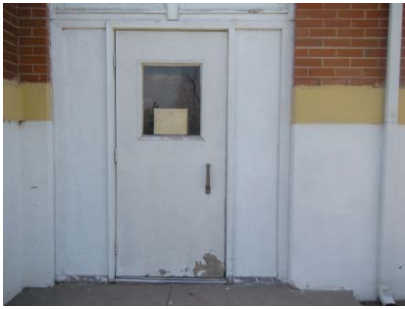
Location: Main
Distress: Beyond Expected Life
Category: Deferred Maintenance
Priority: 3 - Necessary- 2-5 Yrs
Notes: The exterior doors are beyond their expected life. Replacement is recommended.
Correction: Renew System
Qty: 1-Ea.
Condition Budget: \$25,764

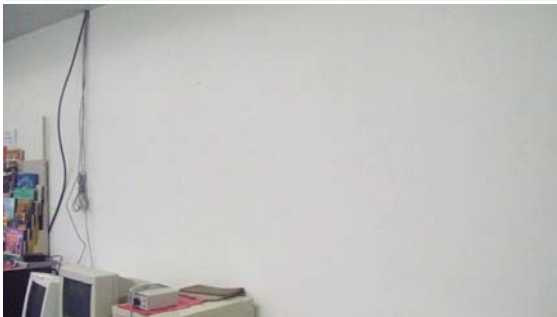
System: C1010 - Partitions

Analysis: The system age is either beyond expected life or does not meet its intended performance under the Guidelines. The system may be in service and functioning but it is recommended to be replaced due to probable increased condition budget needs, the potential failure of its components, or in order to meet the performance Guidelines for this system. The system was installed in 1917. It has a 40-year service life which expired in 1957.

Notes: The interior doors are beyond their expected life. Replacement is recommended. Replacement doors should not swing into corridor space to block egress.

Correction: Renew System
Qty: 1-Ea.
Condition Budget: \$91,607

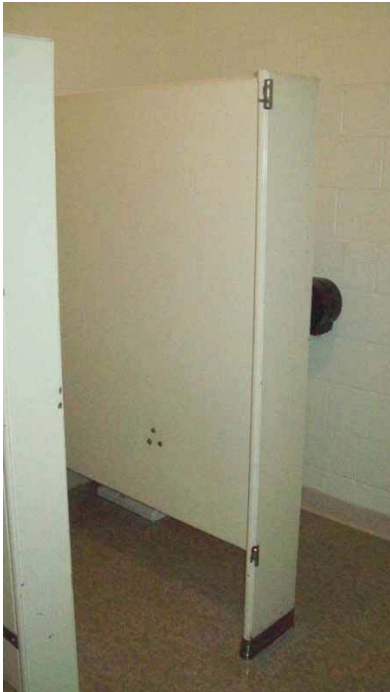
System: C1030 - Fittings

Analysis: The system age is either beyond expected life or does not meet its intended performance under the Guidelines. The system may be in service and functioning but it is recommended to be replaced due to probable increased condition budget needs, the potential failure of its components, or in order to meet the performance Guidelines for this system. The system was installed in 1917. It has a 20-year service life which expired in 1937.

Location: Main
Distress: Beyond Expected Life
Category: Deferred Maintenance
Priority: 3 - Necessary- 2-5 Yrs
Correction: Renew System
Qty: 1-Ea.
Condition Budget: \$81,048

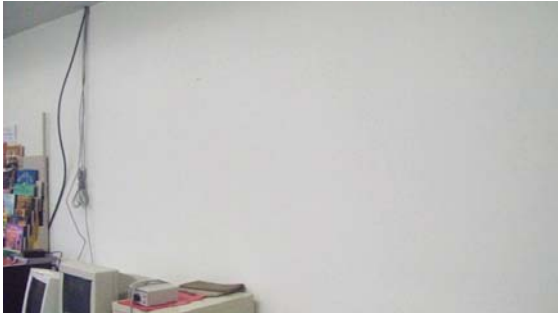
System: C3010 - Wall Finishes

Analysis: The system age is either beyond expected life or does not meet its intended performance under the Guidelines. The system may be in service and functioning but it is recommended to be replaced due to probable increased condition budget needs, the potential failure of its components, or in order to meet the performance Guidelines for this system. The system was installed in 1917. It has a 20-year service life which expired in 1937.

Location: Main
Distress: Beyond Expected Life
Category: Deferred Maintenance
Priority: 3 - Necessary- 2-5 Yrs
Notes: The wall finishes are beyond their expected life. Replacement is recommended.
Correction: Renew System
Qty: 1-Ea.
Condition Budget: \$164,401

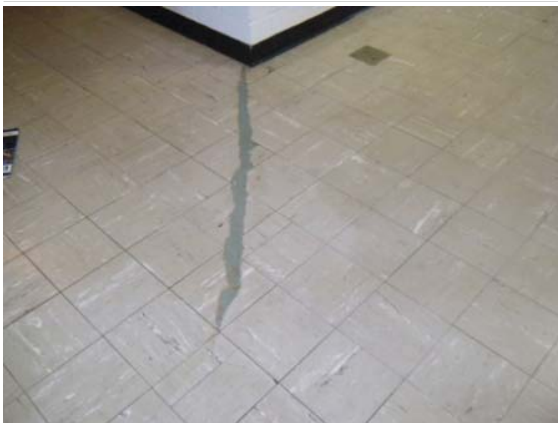
System: C3020 - Floor Finishes

Analysis: The system age is either beyond expected life or does not meet its intended performance under the Guidelines. The system may be in service and functioning but it is recommended to be replaced due to probable increased condition budget needs, the potential failure of its components, or in order to meet the performance Guidelines for this system. The system was installed in 1917. It has a 20-year service life which expired in 1937.

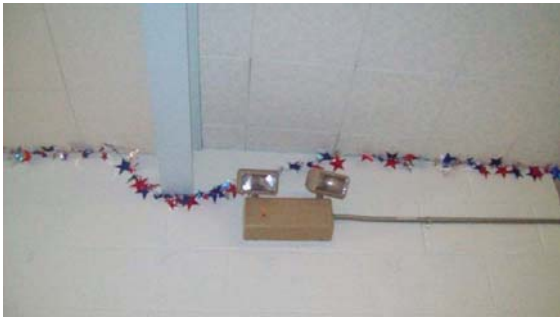
System: C3030 - Ceiling Finishes

Analysis: The system age is either beyond expected life or does not meet its intended performance under the Guidelines. The system may be in service and functioning but it is recommended to be replaced due to probable increased condition budget needs, the potential failure of its components, or in order to meet the performance Guidelines for this system. The system was installed in 1917. It has a 20-year service life which expired in 1937.

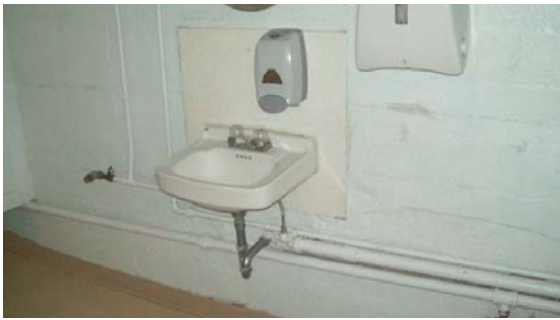
System: D2010 - Plumbing Fixtures

Analysis: The system age is either beyond expected life or does not meet its intended performance under the Guidelines. The system may be in service and functioning but it is recommended to be replaced due to probable increased condition budget needs, the potential failure of its components, or in order to meet the performance Guidelines for this system. The system was installed in 1917. It has a 30-year service life which expired in 1947.

Recommendation: The system should be replaced.

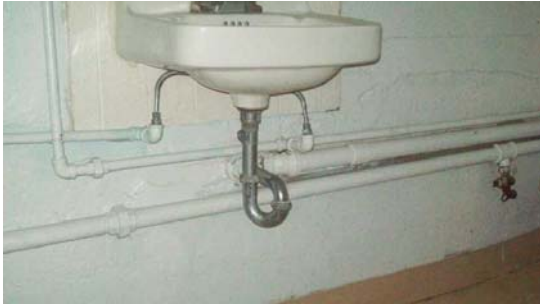
Location: Main
Distress: Beyond Expected Life
Category: Deferred Maintenance
Priority: 3 - Necessary- 2-5 Yrs
Notes: The domestic water distribution piping is beyond its expected life. Replacement is recommended.
Correction: Renew System
Qty: 1-Ea.
Condition Budget: \$21,675

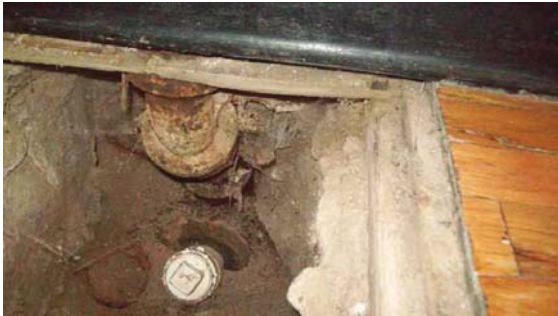
Analysis: The system age is either beyond expected life or does not meet its intended performance under the Guidelines. The system may be in service and functioning but it is recommended to be replaced due to probable increased condition budget needs, the potential failure of its components, or in order to meet the performance Guidelines for this system. The system was installed in 1917. It has a 30-year service life which expired in 1947.
Recommendation: The system should be replaced.

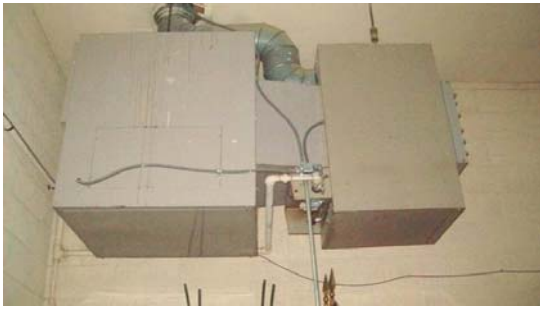
Location: Main
Distress: Beyond Expected Life
Category: Deferred Maintenance
Priority: 3 - Necessary- 2-5 Yrs
Notes: The other plumbing systems are beyond their expected life. Replacement is recommended.

Correction: Renew System
Qty: 1-Ea.
Condition Budget: \$19,630

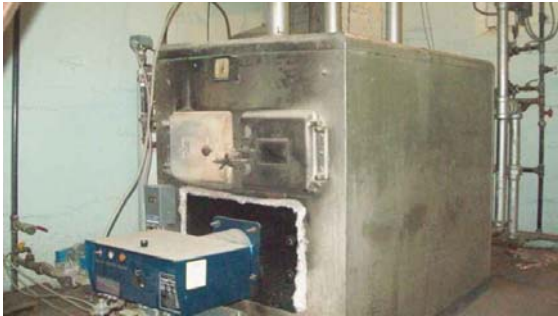
System: D3020 - Heat Generating Systems
Analysis: The system age is either beyond expected life or does not meet its intended performance under the Guidelines. The system may be in service and functioning but it is recommended to be replaced due to probable increased condition budget needs, the potential failure of its components, or in order to meet the performance Guidelines for this system. The system was installed in 1917. It has a 30-year service life which expired in 1947.

Recommendation: The system should be replaced.

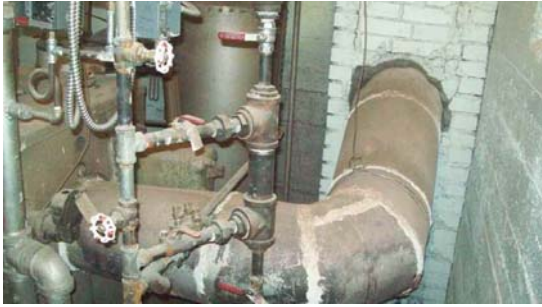
Location: Main
Distress: Beyond Expected Life
Category: Deferred Maintenance
Priority: 3 - Necessary- 2-5 Yrs
Notes: The distribution piping is beyond its expected life. Replacement is recommended.
Correction: Renew System
Qty: 1-Ea.
Condition Budget: \$313,262

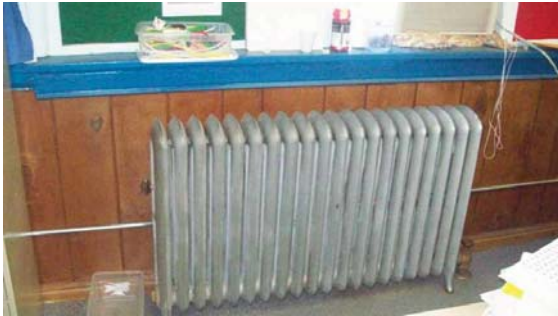
System: D3050 - Terminal & Package Units
Analysis: The system age is either beyond expected life or does not meet its intended performance under the Guidelines. The system may be in service and functioning but it is recommended to be replaced due to probable increased condition budget needs, the potential failure of its components, or in order to meet the performance Guidelines for this system. The system was installed in 1917. It has a 15-year service life which expired in 1932.

Recommendation: The system should be replaced.

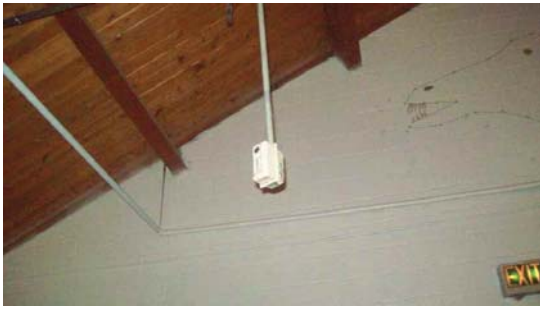
Location: Main
Distress: Beyond Expected Life
Category: Deferred Maintenance
Priority: 3 - Necessary- 2-5 Yrs
Notes: The controls and instrumentation are beyond their expected life. Replacement is recommended.

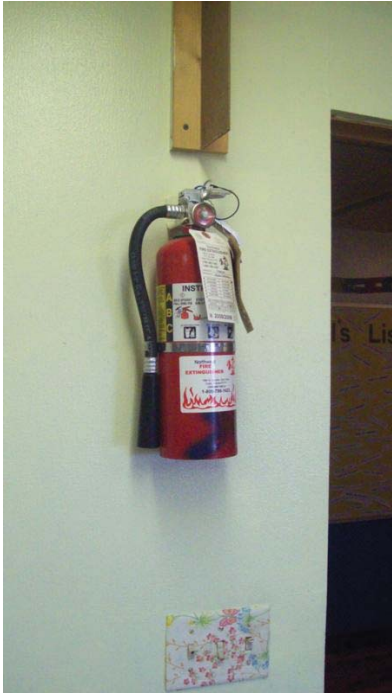
System: D4030 - Fire Protection Specialties

Analysis: The system age is either beyond expected life or does not meet its intended performance under the Guidelines. The system may be in service and functioning but it is recommended to be replaced due to probable increased condition budget needs, the potential failure of its components, or in order to meet the performance Guidelines for this system. The system was installed in 1917. It has a 15-year service life which expired in 1932.

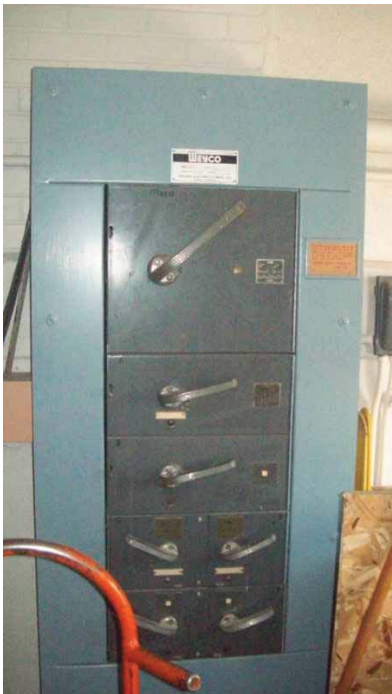
System: D5010 - Electrical Service/Distribution

Analysis: The system age is either beyond expected life or does not meet its intended performance under the Guidelines. The system may be in service and functioning but it is recommended to be replaced due to probable increased condition budget needs, the potential failure of its components, or in order to meet the performance Guidelines for this system. The system was installed in 1917. It has a 30-year service life which expired in 1947.

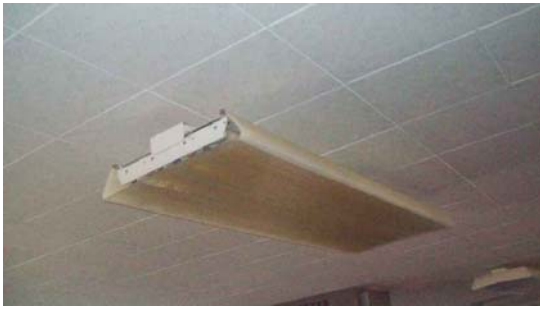
Location: Main
Distress: Beyond Expected Life
Category: Deferred Maintenance
Priority: 3 - Necessary- 2-5 Yrs
Notes: The lighting and branch wiring are beyond their expected life. Replacement is recommended.
Correction: Renew System
Qty: 1-Ea.
Condition Budget: \$444,538

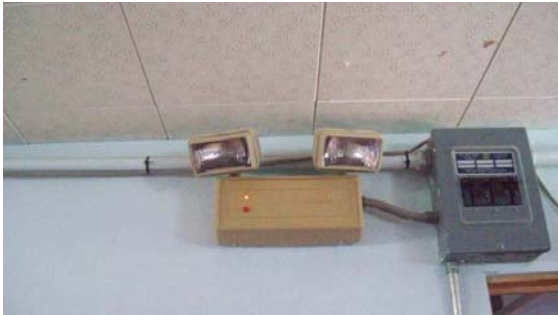
System: D5090 - Other Electrical Systems

Analysis: The system age is either beyond expected life or does not meet its intended performance under the Guidelines. The system may be in service and functioning but it is recommended to be replaced due to probable increased condition budget needs, the potential failure of its components, or in order to meet the performance Guidelines for this system. The system was installed in 1917. It has a 15-year service life which expired in 1932.

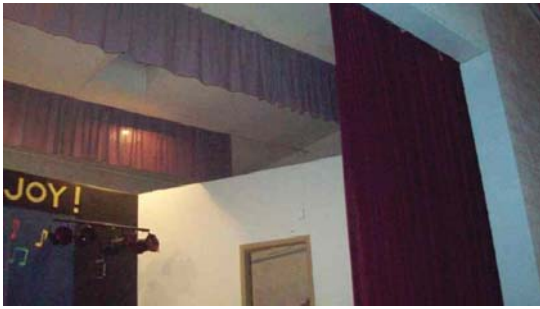
Location: Main
Distress: Beyond Expected Life
Category: Deferred Maintenance
Priority: 3 - Necessary- 2-5 Yrs
Notes: The institutional equipment is beyond its expected life. Replacement is recommended.
Correction: Renew System
Qty: 1-Ea.
Condition Budget: \$3,681

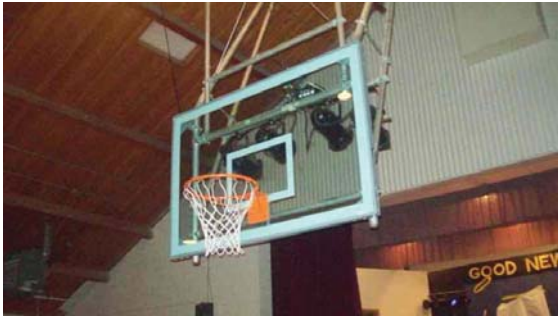
System: E1090 - Other Equipment
Analysis: The system age is either beyond expected life or does not meet its intended performance under the Guidelines. The system may be in service and functioning but it is recommended to be replaced due to probable increased condition budget needs, the potential failure of its components, or in order to meet the performance Guidelines for this system. The system was installed in 1917. It has a 20-year service life which expired in 1937.

Recommendation: The system should be replaced.
