# School Assessment Report

District: Hi-Plains R-23  
School: Hi-Plains HS  
Date: Apr 01, 2011

### School Name: Hi-Plains HS

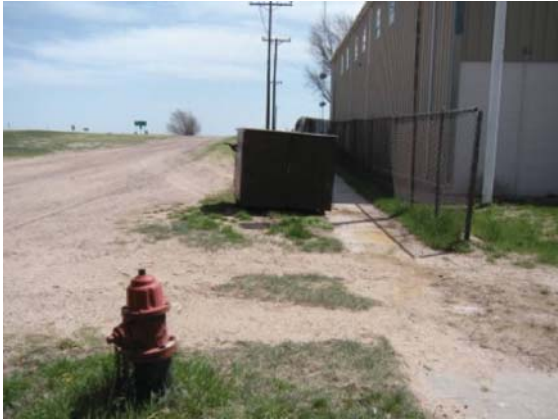
**System:** G2010 - Roadways

**Analysis:** The system age is either beyond expected life or does not meet its intended performance under the Guidelines. The system may be in service and functioning but it is recommended to be replaced due to probable increased condition budget needs, the potential failure of its components, or in order to meet the performance Guidelines for this system. The system was installed in 1955. It has a 50-year service life which expired in 2005.

**Recommendation:** The system should be replaced.

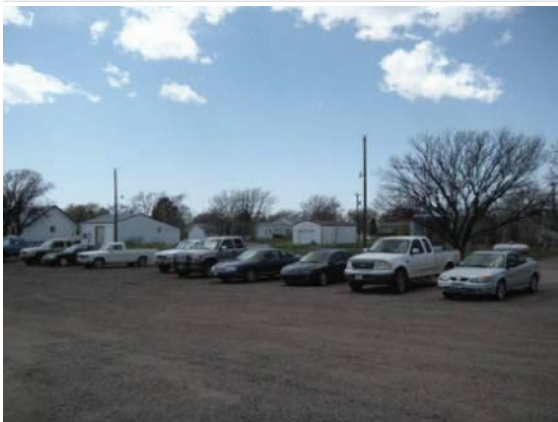
**System:** G2020 - Parking Lots

**Analysis:** The system age is either beyond expected life or does not meet its intended performance under the Guidelines. The system may be in service and functioning but it is recommended to be replaced due to probable increased condition budget needs, the potential failure of its components, or in order to meet the performance Guidelines for this system. The system was installed in 1955. It has a 50-year service life which expired in 2005.

**Recommendation:** The system should be replaced.

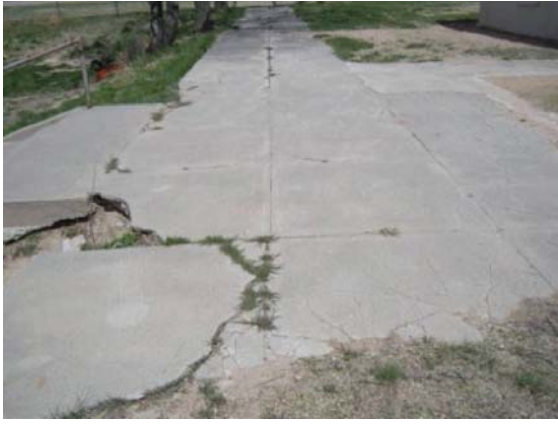
**System:** G2030 - Pedestrian Paving

**Analysis:** The system age is either beyond expected life or does not meet its intended performance under the Guidelines. The system may be in service and functioning but it is recommended to be replaced due to probable increased condition budget needs, the potential failure of its components, or in order to meet the performance Guidelines for this system. The system was installed in 1955. It has a 50-year service life which expired in 2005.

**Location:** Site  
**Distress:** Beyond Expected Life  
**Category:** Deferred Maintenance  
**Priority:** 3 - Necessary- 2-5 Yrs  
**Notes:** Pedestrian pavings are failing as they have multiple cracks and need to be reworked.

**Recommendation:** The system should be replaced.

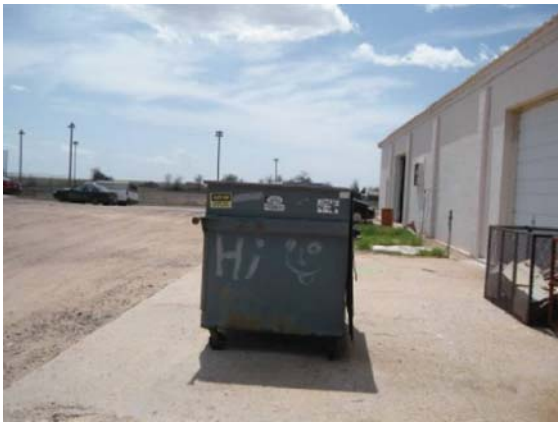
**System:** G2040 - Site Development

**Analysis:** The system is missing.

**Location:** Site  
**Material:** Site Development  
**Distress:** Missing  
**Category:** Environmental  
**Priority:** 3 - Necessary- 2-5 Yrs  
**Notes:** Fencing around rubbish containers is missing. Installation recommended.

**Recommendation:** The system should be installed.

**Correction:** Replace and/or add fencing for security/appearance

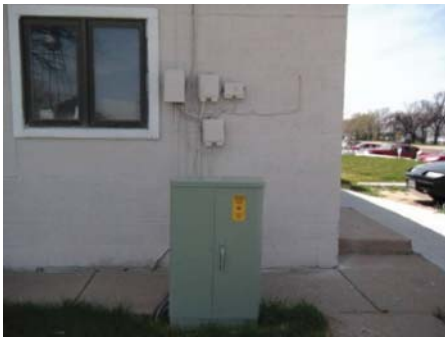
**Location:** Site  
**Material:** Site Development  
**Distress:** Missing  
**Category:** Compliance  
**Priority:** 3 - Necessary- 2-5 Yrs  
**Notes:** The main electrical equipment needs to be fenced.

**Correction:** Replace and/or add fencing for security/appearance

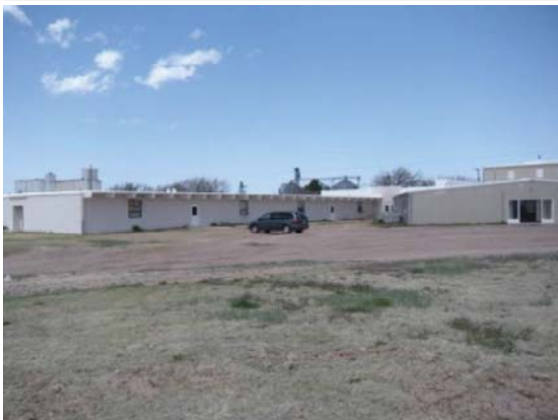
System: G2050 - Landscaping

Analysis: The system age is either beyond expected life or does not meet its intended performance under the Guidelines. The system may be in service and functioning but it is recommended to be replaced due to probable increased condition budget needs, the potential failure of its components, or in order to meet the performance Guidelines for this system. The system was installed in 1955. It has a 10-year service life which expired in 1965.

Location: Site  
Distress: Beyond Expected Life  
Category: Deferred Maintenance  
Priority: 3 - Necessary- 2-5 Yrs  
Notes: Site has severe erosion with patches of dead grass and scrubs; therefore it needs to be reworked.  
Correction: Renew System  
Qty: 1-Ea.  
Condition Budget: \$144,170

Recommendation: The system should be replaced.

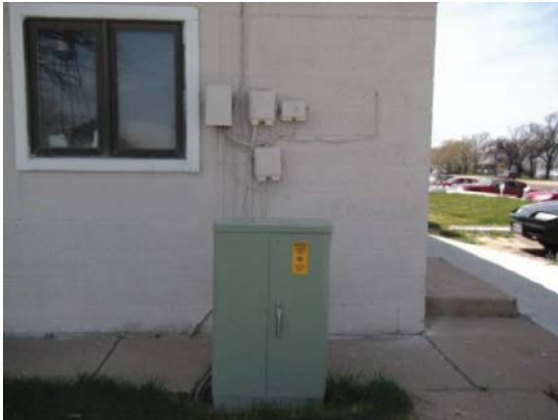
**System:** G4010 - Electrical Distribution

**Analysis:** The system age is either beyond expected life or does not meet its intended performance under the Guidelines. The system may be in service and functioning but it is recommended to be replaced due to probable increased condition budget needs, the potential failure of its components, or in order to meet the performance Guidelines for this system. The system was installed in 1955. It has a 30-year service life which expired in 1985.

**Recommendation:** The system should be replaced.

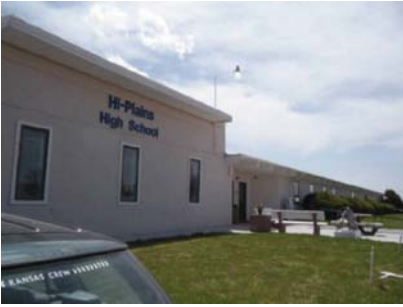
Location: Site  
Distress: Beyond Expected Life  
Category: Deferred Maintenance  
Priority: 3 - Necessary- 2-5 Yrs  
Notes: The building does not have energy efficient fixtures and site lighting needs to be upgraded.  
Correction: Renew System  
Qty: 1-Ea.  
Condition Budget: \$70,626

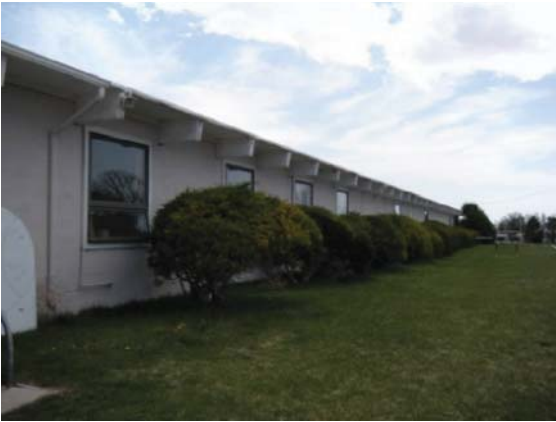
System: G4030 - Site Communication and Security  
Analysis: The system age is either beyond expected life or does not meet its intended performance under the Guidelines. The system may be in service and functioning but it is recommended to be replaced due to probable increased condition budget needs, the potential failure of its components, or in order to meet the performance Guidelines for this system. The system was installed in 1955. It has a 30-year service life which expired in 1985.

Location: Site  
Distress: Beyond Expected Life  
Category: Deferred Maintenance  
Priority: 3 - Necessary- 2-5 Yrs  
Notes: The site communication system is outdated and needs to be replaced.  
Correction: Renew System  
Qty: 1-Ea.  
Condition Budget: \$32,103

Recommendation: The system should be replaced.

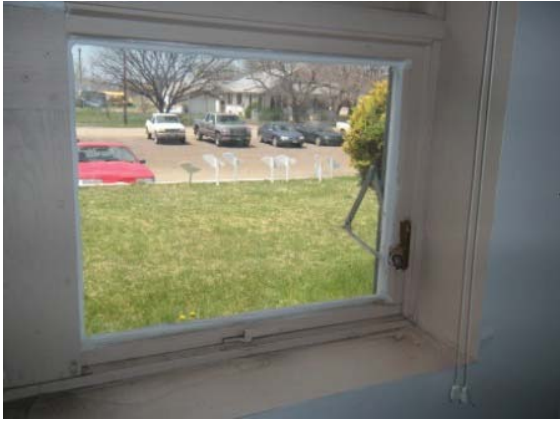
**System:** B2020 - Exterior Windows

**Analysis:** The system age is either beyond expected life or does not meet its intended performance under the Guidelines. The system may be in service and functioning but it is recommended to be replaced due to probable increased condition budget needs, the potential failure of its components, or in order to meet the performance Guidelines for this system. The system was installed in 1955. It has a 30-year service life which expired in 1985.

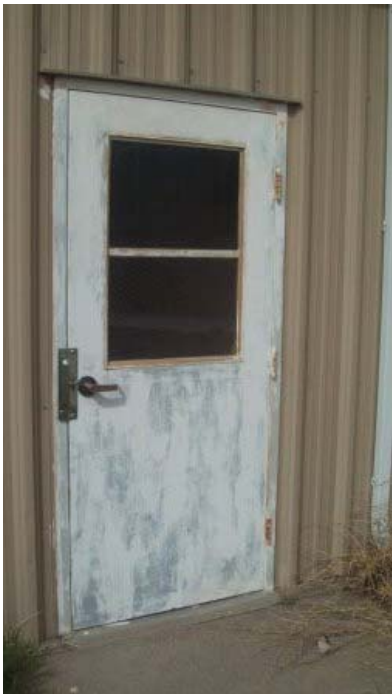
**System:** B2030 - Exterior Doors

**Analysis:** The system age is either beyond expected life or does not meet its intended performance under the Guidelines. The system may be in service and functioning but it is recommended to be replaced due to probable increased condition budget needs, the potential failure of its components, or in order to meet the performance Guidelines for this system. The system was installed in 1955. It has a 30-year service life which expired in 1985.

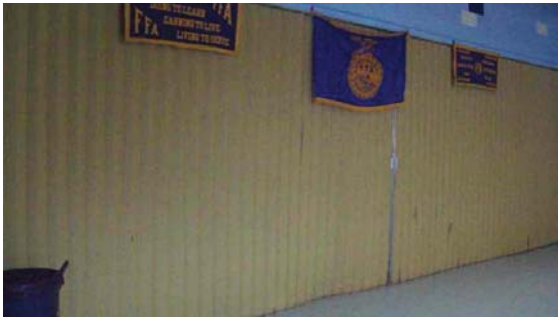
**System:** C1010 - Partitions

**Analysis:** The system age is either beyond expected life or does not meet its intended performance under the Guidelines. The system may be in service and functioning but it is recommended to be replaced due to probable increased condition budget needs, the potential failure of its components, or in order to meet the performance Guidelines for this system. The system was installed in 1955. It has a 40-year service life which expired in 1995.

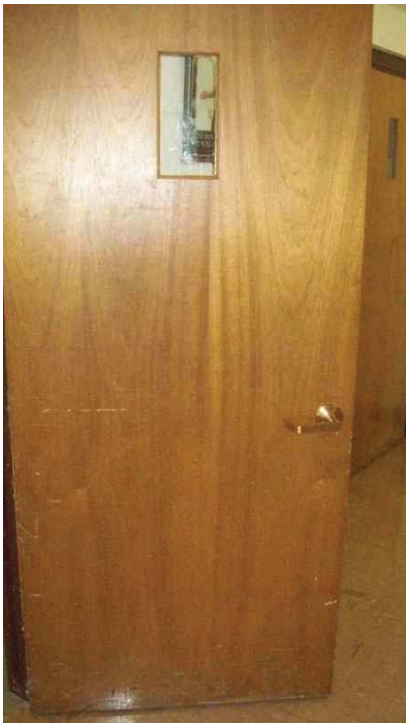
**System:** C1020 - Interior Doors

**Analysis:** The system age is either beyond expected life or does not meet its intended performance under the Guidelines. The system may be in service and functioning but it is recommended to be replaced due to probable increased condition budget needs, the potential failure of its components, or in order to meet the performance Guidelines for this system. The system was installed in 1955. It has a 40-year service life which expired in 1995.

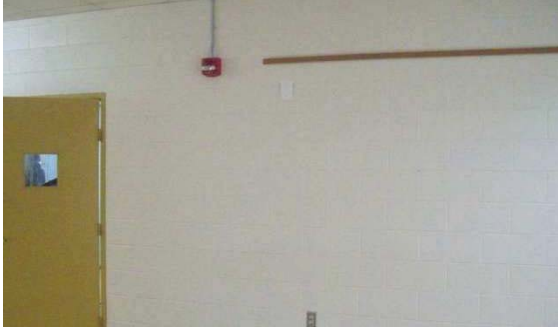
System: C3010 - Wall Finishes

Analysis: The system age is either beyond expected life or does not meet its intended performance under the Guidelines. The system may be in service and functioning but it is recommended to be replaced due to probable increased condition budget needs, the potential failure of its components, or in order to meet the performance Guidelines for this system. The system was installed in 1955. It has a 20-year service life which expired in 1975.

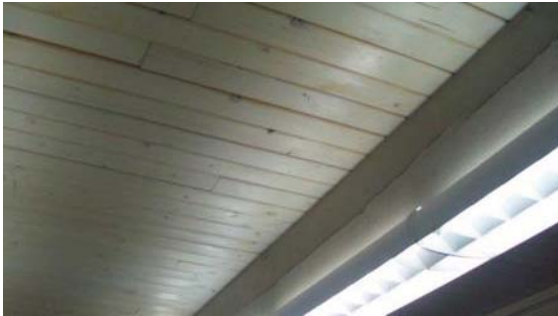
System: C3030 - Ceiling Finishes

Analysis: The system age is either beyond expected life or does not meet its intended performance under the Guidelines. The system may be in service and functioning but it is recommended to be replaced due to probable increased condition budget needs, the potential failure of its components, or in order to meet the performance Guidelines for this system. The system was installed in 1955. It has a 20-year service life which expired in 1975.

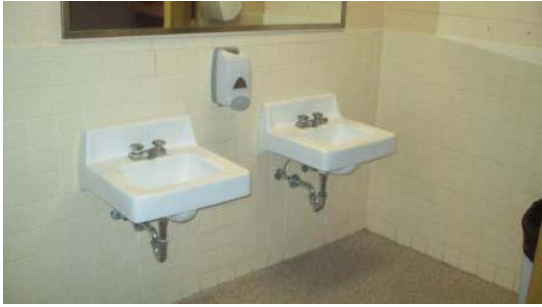
Location: Main  
Distress: Beyond Expected Life  
Category: Deferred Maintenance  
Priority: 3 - Necessary- 2-5 Yrs  
Notes: The plumbing fixtures are beyond their expected life. Replacement is recommended.  
Correction: Renew System  
Qty: 1-Ea.  
Condition Budget: \$393,097

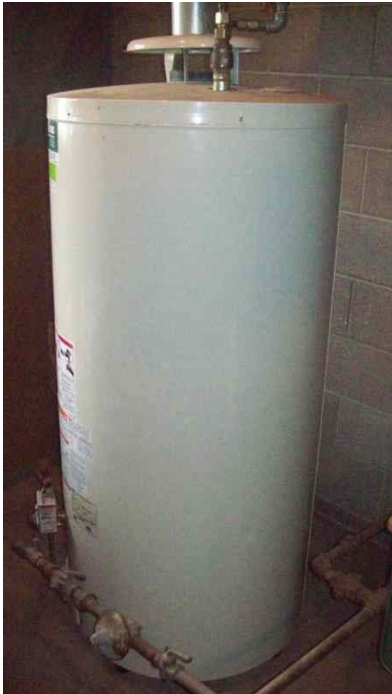
System: D2020 - Domestic Water Distribution  
Analysis: The system age is either beyond expected life or does not meet its intended performance under the Guidelines. The system may be in service and functioning but it is recommended to be replaced due to probable increased condition budget needs, the potential failure of its components, or in order to meet the performance Guidelines for this system. The system was installed in 1955. It has a 30-year service life which expired in 1985.

Recommendation: The system should be replaced.

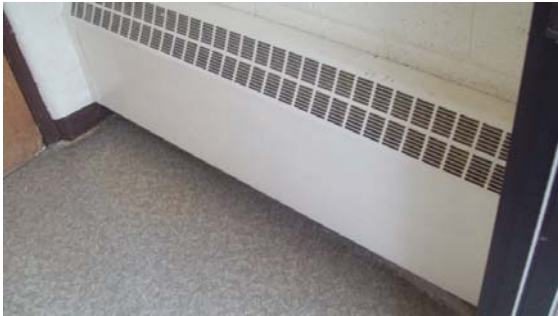
System: D3040 - Distribution Systems  
Analysis: The system age is either beyond expected life or does not meet its intended performance under the Guidelines. The system may be in service and functioning but it is recommended to be replaced due to probable increased condition budget needs, the potential failure of its components, or in order to meet the performance Guidelines for this system. The system was installed in 1955. It has a 30-year service life which expired in 1985.

Recommendation: The system should be replaced.

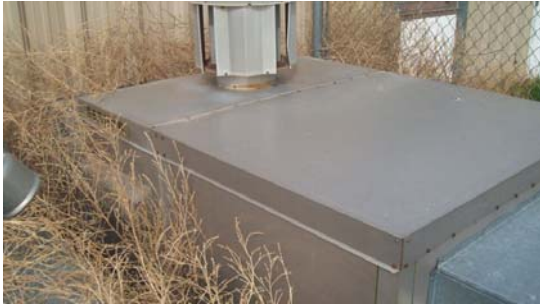
Location: Main  
Distress: Beyond Expected Life  
Category: Deferred Maintenance  
Priority: 3 - Necessary- 2-5 Yrs  
Notes: The terminal and package units are beyond their expected life.

Correction: Renew System  
Qty: 1-Ea.  
Condition Budget: \$1,696,415

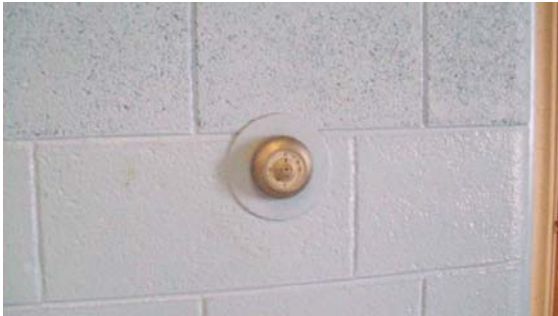
System: D3060 - Controls & Instrumentation

Analysis: The system age is either beyond expected life or does not meet its intended performance under the Guidelines. The system may be in service and functioning but it is recommended to be replaced due to probable increased condition budget needs, the potential failure of its components, or in order to meet the performance Guidelines for this system. The system was installed in 1955. It has a 20-year service life which expired in 1975.

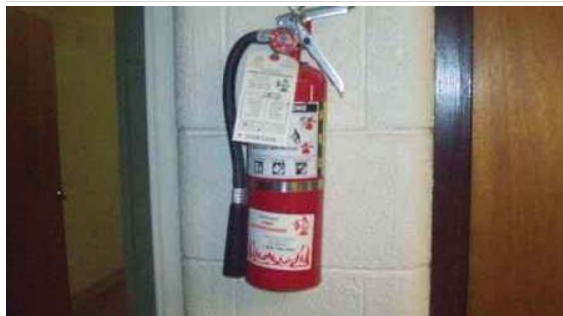
System: D4030 - Fire Protection Specialties

Analysis: The system age is either beyond expected life or does not meet its intended performance under the Guidelines. The system may be in service and functioning but it is recommended to be replaced due to probable increased condition budget needs, the potential failure of its components, or in order to meet the performance Guidelines for this system. The system was installed in 1955. It has a 15-year service life which expired in 1970.

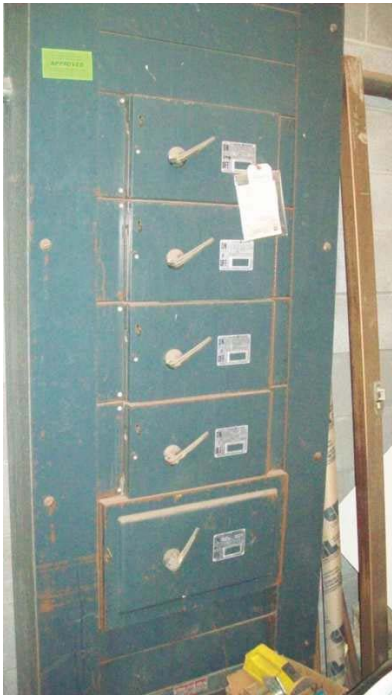
**System:** D5010 - Electrical Service/Distribution

**Analysis:** The system age is either beyond expected life or does not meet its intended performance under the Guidelines. The system may be in service and functioning but it is recommended to be replaced due to probable increased condition budget needs, the potential failure of its components, or in order to meet the performance Guidelines for this system. The system was installed in 1955. It has a 30-year service life which expired in 1985.

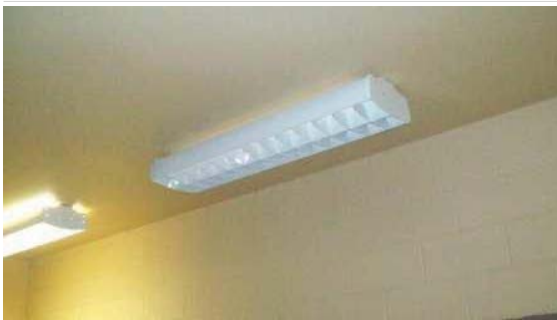
**System:** D5020 - Lighting and Branch Wiring

**Analysis:** The system age is either beyond expected life or does not meet its intended performance under the Guidelines. The system may be in service and functioning but it is recommended to be replaced due to probable increased condition budget needs, the potential failure of its components, or in order to meet the performance Guidelines for this system. The system was installed in 1955. It has a 30-year service life which expired in 1985.

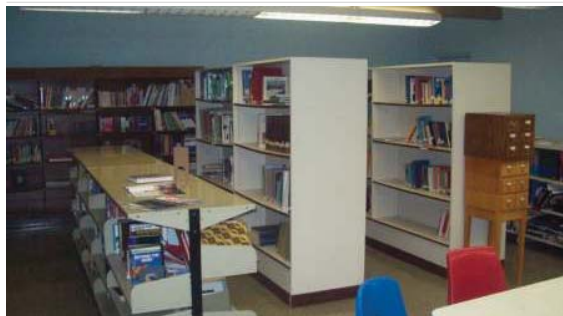
**System:** E1020 - Institutional Equipment

**Analysis:** The system age is either beyond expected life or does not meet its intended performance under the Guidelines. The system may be in service and functioning but it is recommended to be replaced due to probable increased condition budget needs, the potential failure of its components, or in order to meet the performance Guidelines for this system. The system was installed in 1955. It has a 20-year service life which expired in 1975.

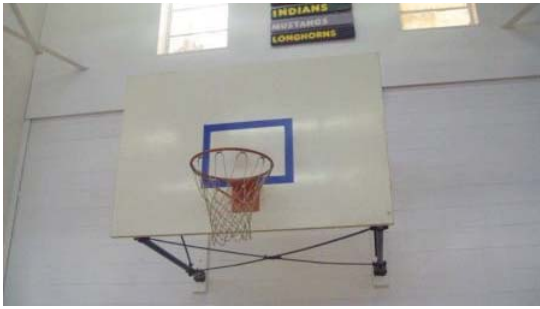
Location: Main  
Distress: Beyond Expected Life  
Category: Deferred Maintenance  
Priority: 3 - Necessary- 2-5 Yrs  
Notes: The other equipment is beyond its expected life. Replacement is recommended.

Correction: Renew System  
Qty: 1-Ea.  
Condition Budget: \$48,176

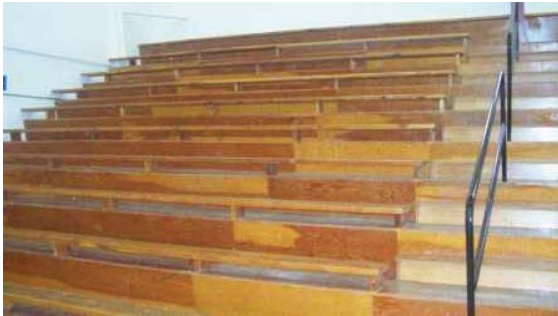
System: E2010 - Fixed Furnishings  
Analysis: The system age is either beyond expected life or does not meet its intended performance under the Guidelines. The system may be in service and functioning but it is recommended to be replaced due to probable increased condition budget needs, the potential failure of its components, or in order to meet the performance Guidelines for this system. The system was installed in 1955. It has a 20-year service life which expired in 1975.

Recommendation: The system should be replaced.

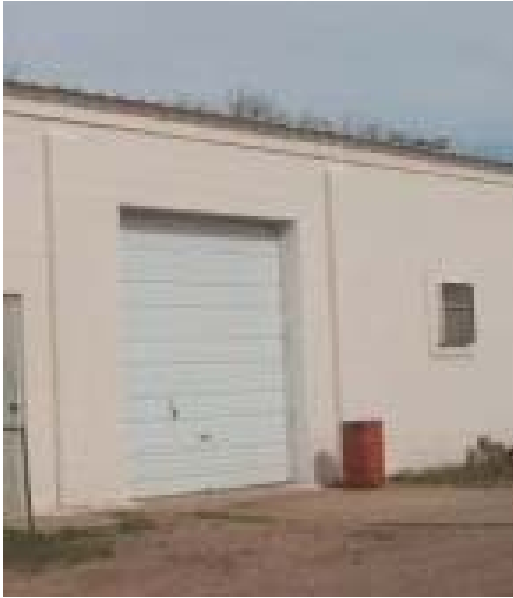
**System:** B2030 - Exterior Doors

**Analysis:** The system age is either beyond expected life or does not meet its intended performance under the Guidelines. The system may be in service and functioning but it is recommended to be replaced due to probable increased condition budget needs, the potential failure of its components, or in order to meet the performance Guidelines for this system. The system was installed in 1964. It has a 30-year service life which expired in 1994.

**Condition Budget:** \$6,904

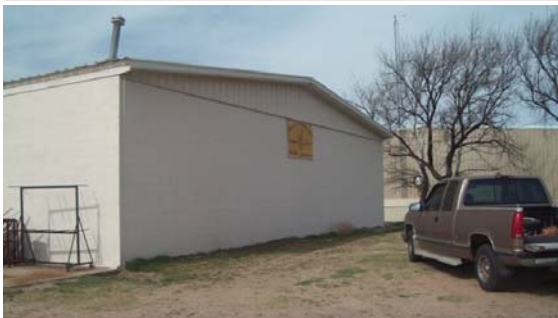
**System:** B3010 - Roof Coverings

**Analysis:** The system age is either beyond expected life or does not meet its intended performance under the Guidelines. The system may be in service and functioning but it is recommended to be replaced due to probable increased condition budget needs, the potential failure of its components, or in order to meet the performance Guidelines for this system. The system was installed in 1964. It has a 20-year service life which expired in 1984.

**Condition Budget:** \$120,495

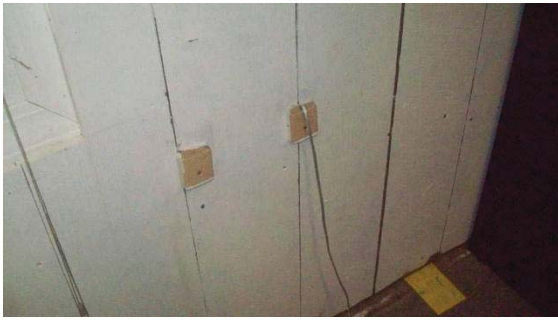
**System:** C1010 - Partitions

**Analysis:** The system age is either beyond expected life or does not meet its intended performance under the Guidelines. The system may be in service and functioning but it is recommended to be replaced due to probable increased condition budget needs, the potential failure of its components, or in order to meet the performance Guidelines for this system. The system was installed in 1964. It has a 40-year service life which expired in 2004.

**Condition Budget:** \$50,390

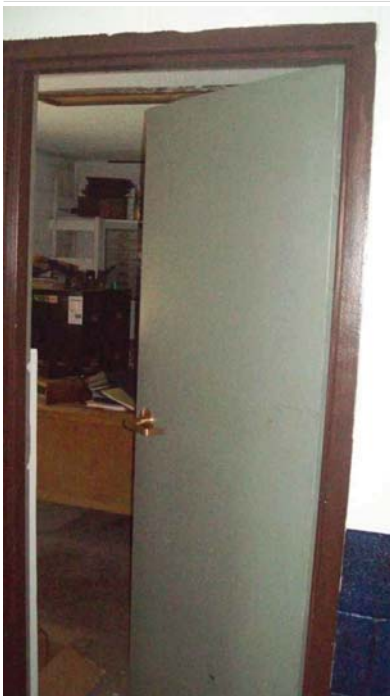
**System:** C1020 - Interior Doors

**Analysis:** The system age is either beyond expected life or does not meet its intended performance under the Guidelines. The system may be in service and functioning but it is recommended to be replaced due to probable increased condition budget needs, the potential failure of its components, or in order to meet the performance Guidelines for this system. The system was installed in 1964. It has a 40-year service life which expired in 2004.

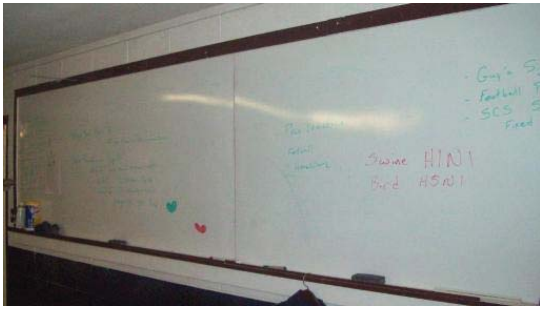
Location: Vo/Ag  
Distress: Beyond Expected Life  
Category: Deferred Maintenance  
Priority: 3 - Necessary- 2-5 Yrs  
Notes: The fittings are beyond their expected life. Replacement is recommended.  
Correction: Renew System  
Qty: 1-Ea.  
Condition Budget: \$23,202

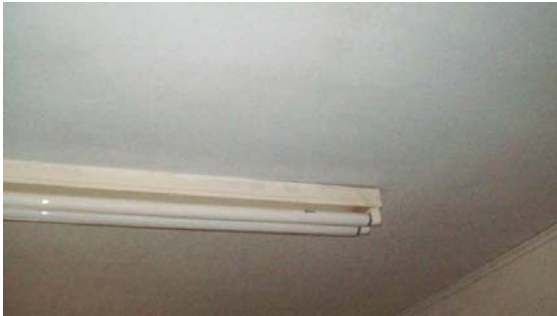
System: C3030 - Ceiling Finishes

Analysis: The system age is either beyond expected life or does not meet its intended performance under the Guidelines. The system may be in service and functioning but it is recommended to be replaced due to probable increased condition budget needs, the potential failure of its components, or in order to meet the performance Guidelines for this system. The system was installed in 1964. It has a 20-year service life which expired in 1984.

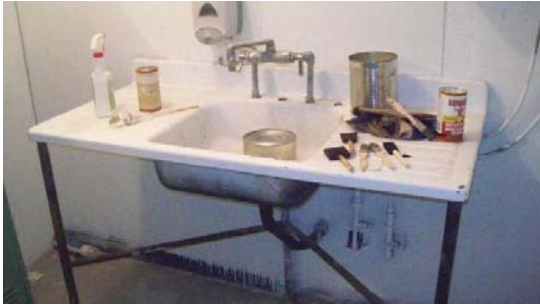
Location: Vo/Ag  
Distress: Beyond Expected Life  
Category: Deferred Maintenance  
Priority: 3 - Necessary- 2-5 Yrs  
Notes: The plumbing fixtures are beyond their expected life. Replacement is recommended.  
Correction: Renew System  
Qty: 1-Ea.  
Condition Budget: \$58,290

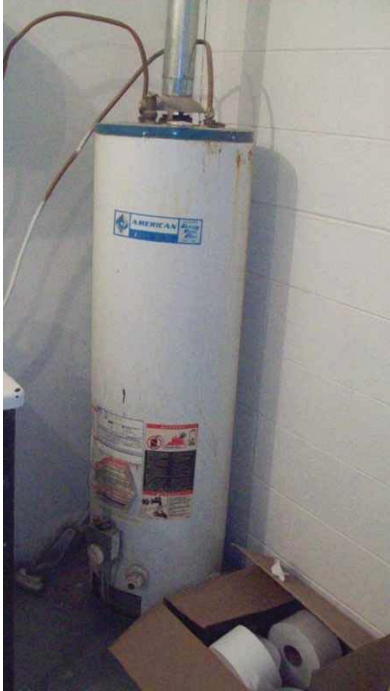
System: D2020 - Domestic Water Distribution

Analysis: The system age is either beyond expected life or does not meet its intended performance under the Guidelines. The system may be in service and functioning but it is recommended to be replaced due to probable increased condition budget needs, the potential failure of its components, or in order to meet the performance Guidelines for this system. The system was installed in 1964. It has a 30-year service life which expired in 1994.

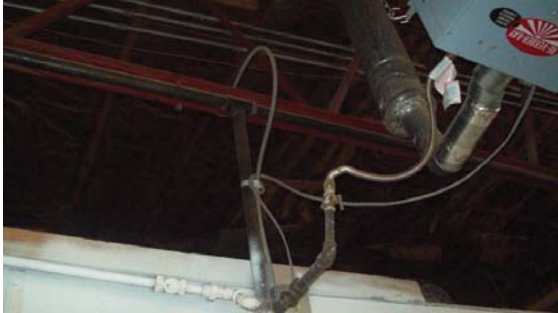
System: D2090 - Other Plumbing Systems

Analysis: The system age is either beyond expected life or does not meet its intended performance under the Guidelines. The system may be in service and functioning but it is recommended to be replaced due to probable increased condition budget needs, the potential failure of its components, or in order to meet the performance Guidelines for this system. The system was installed in 1964. It has a 20-year service life which expired in 1984.

Recommendation: The system should be replaced.

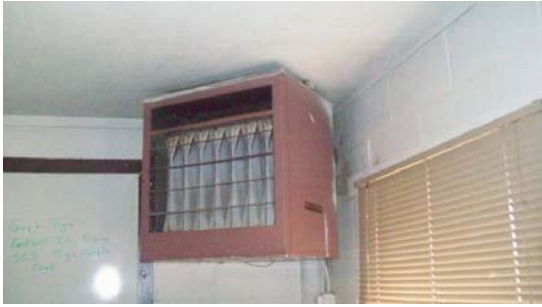
Location: Vo/Ag  
Distress: Beyond Expected Life  
Category: Deferred Maintenance  
Priority: 3 - Necessary- 2-5 Yrs  
Notes: The terminal and package units are beyond their expected life. Replacement is recommended.

Condition Budget: \$251,311

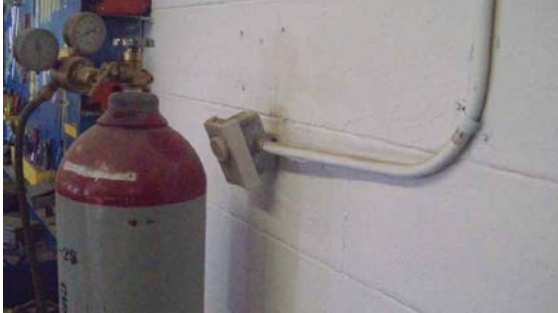
System: D3060 - Controls & Instrumentation

Analysis: The system age is either beyond expected life or does not meet its intended performance under the Guidelines. The system may be in service and functioning but it is recommended to be replaced due to probable increased condition budget needs, the potential failure of its components, or in order to meet the performance Guidelines for this system. The system was installed in 1964. It has a 20-year service life which expired in 1984.

Condition Budget: \$36,298

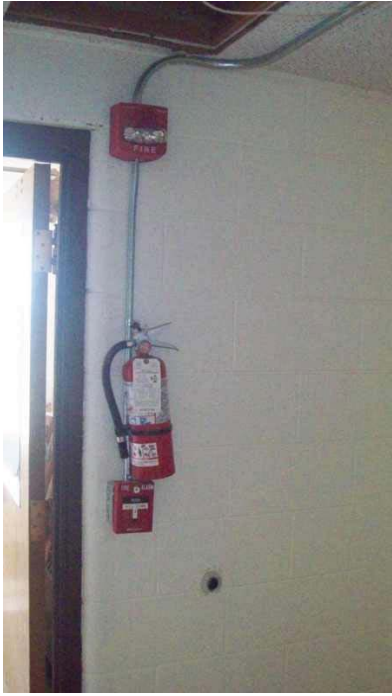
**System:** D4030 - Fire Protection Specialties

**Analysis:** The system age is either beyond expected life or does not meet its intended performance under the Guidelines. The system may be in service and functioning but it is recommended to be replaced due to probable increased condition budget needs, the potential failure of its components, or in order to meet the performance Guidelines for this system. The system was installed in 1964. It has a 15-year service life which expired in 1979.

**Condition Budget:** \$925

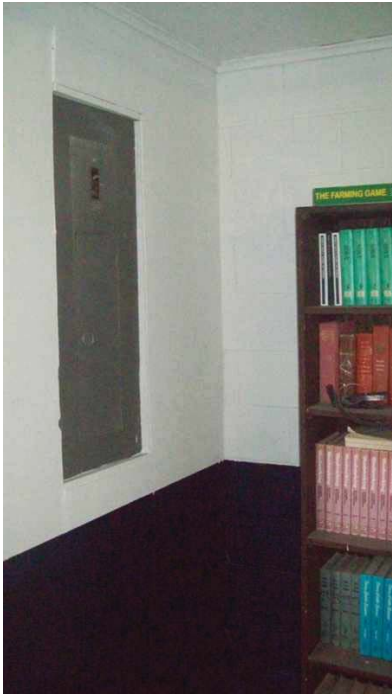
**System:** D5010 - Electrical Service/Distribution

**Analysis:** The system age is either beyond expected life or does not meet its intended performance under the Guidelines. The system may be in service and functioning but it is recommended to be replaced due to probable increased condition budget needs, the potential failure of its components, or in order to meet the performance Guidelines for this system. The system was installed in 1964. It has a 30-year service life which expired in 1994.

**Recommendation:** The system should be replaced.

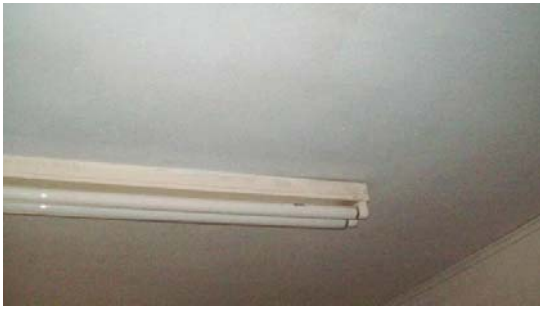
Location: Vo/Ag  
Distress: Beyond Expected Life  
Category: Deferred Maintenance  
Priority: 3 - Necessary- 2-5 Yrs  
Notes: The lighting and branch wiring are beyond their expected life. Replacement is recommended.  
Correction: Renew System  
Qty: 1-Ea.  
Condition Budget: \$118,218
